**EVALUATION OF WELDED AND BRAZED
STAINLESS STEELS AND SUPERALLOYS IN A
CORROSIVE ENVIRONMENT**

TECHNICAL REPORT AFML-TR-67-258

October 1968

Air Force Materials Laboratory
Air Force Systems Command
Wright-Patterson Air Force Base, Ohio 45433

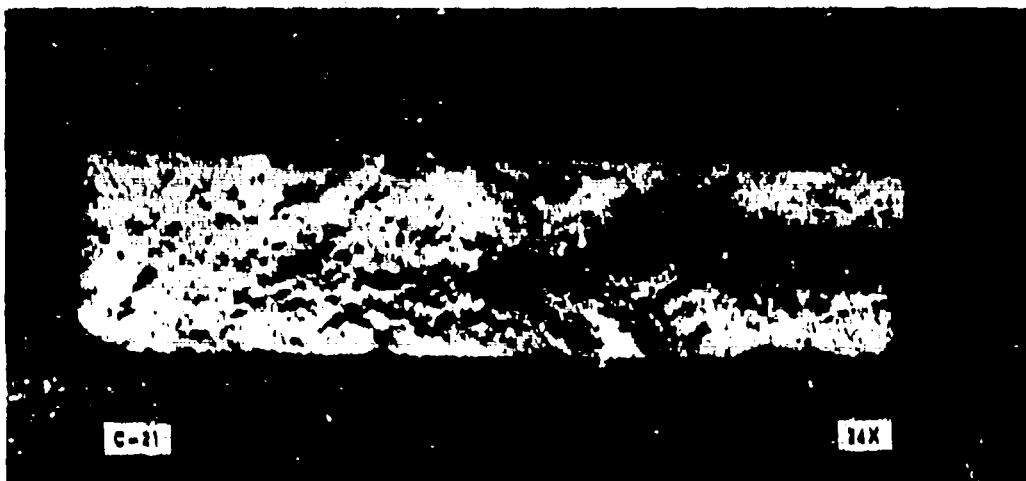
Figure 36 Brazed Specimen C-21 After Tensile Test. Arrow Points to Crack at Fracture Origin. (Environment-test conditions: 800F, 130 ksi, salt; duration: 63 cycles) (H-64394)
Mag: 24X

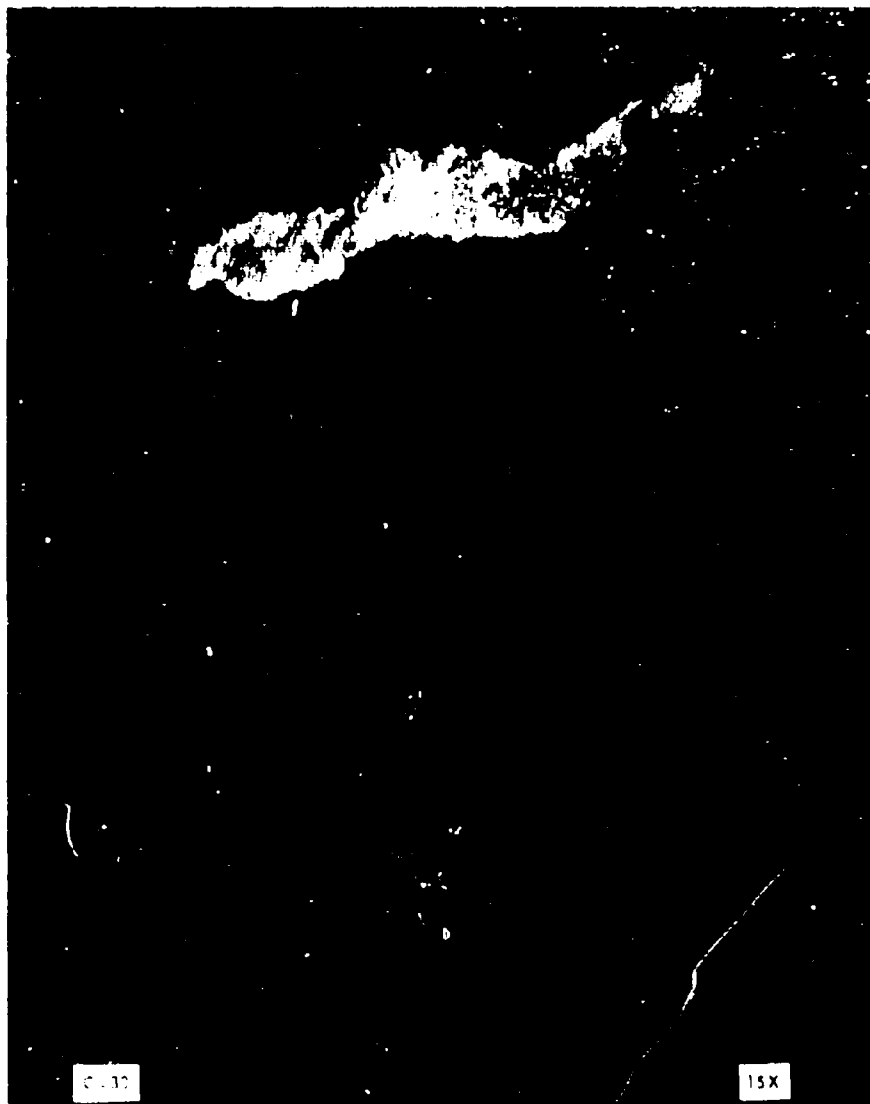
Figure 43 Brazed Specimen C-30. Failed During 55th Cycle. Arrows Point to Cracks in the Stained Area. (Environmental-test conditions: 800F, 130 ksi, no salt; scheduled duration: 63 cycles) (H-64893)
Mag: 15X
